RE: Notice of Intent for 8 View Avenue, Sovereign Builders, Inc.  
MADEP File Number 246-0785  
Second Peer Review

**Second Review of Stormwater Management System for View Avenue Condominium Project,  
Northampton, MA**

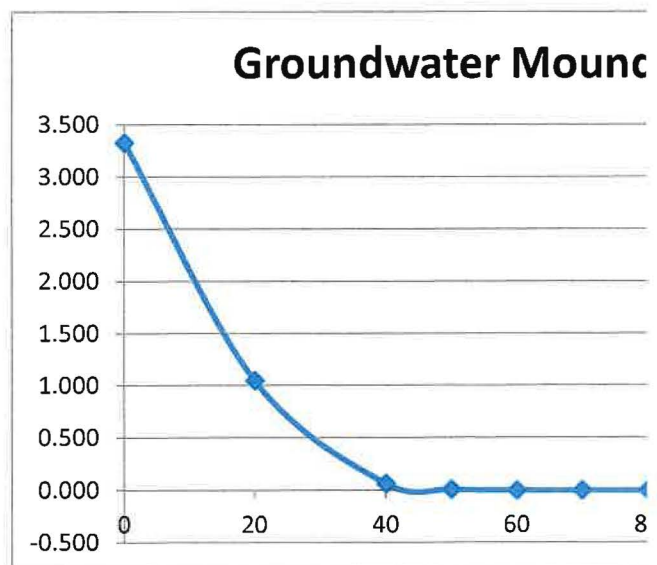
Using the parameters discussed above, the Hantush model predicts a groundwater mound at the center of the infiltration system of 3.3 feet. This mound will therefore extend to within the infiltration system.

Mound at center  
 of system = 3.33 feet
