Estimated Fill Limits

Sovereign Builders  
 8 View Avenue  
 Northampton, MA

**EXISTING CONDITIONS PLAN**

SITE DETAILS

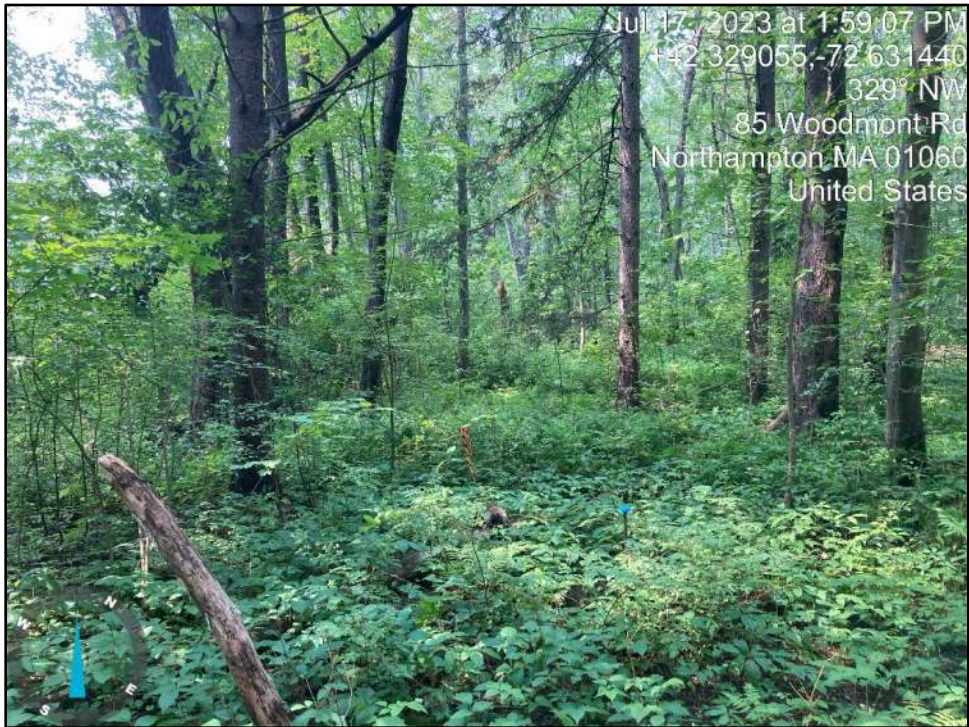
**Photo 1. Overview of wetland edge located at 8 View Ave looking northwest.**

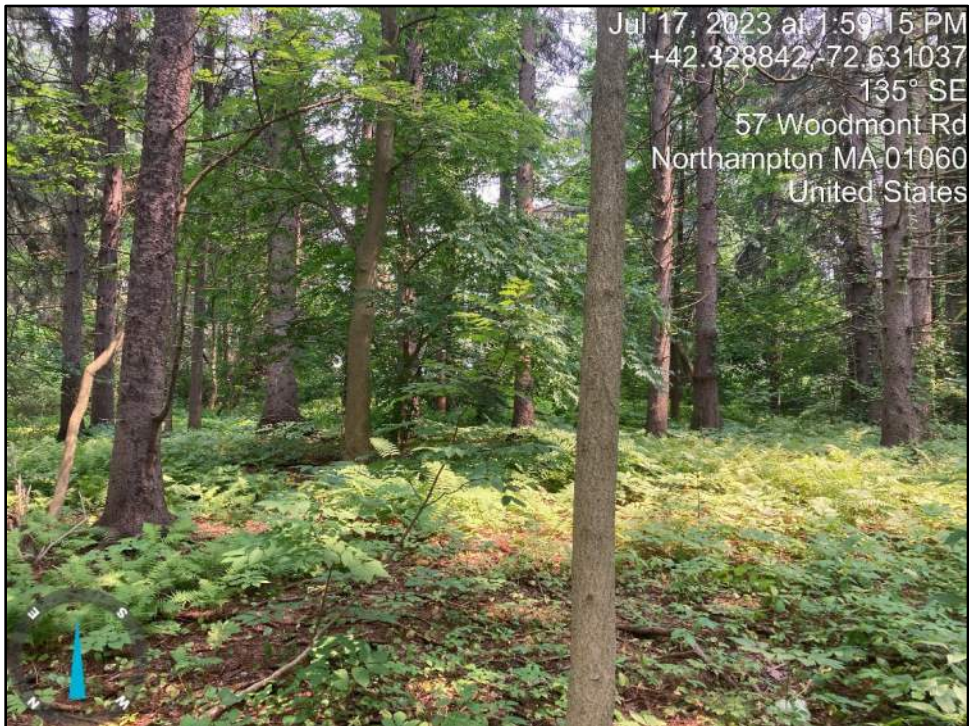
**Photo 2. Upland vegetation located at 8 View Ave looking southeast.**

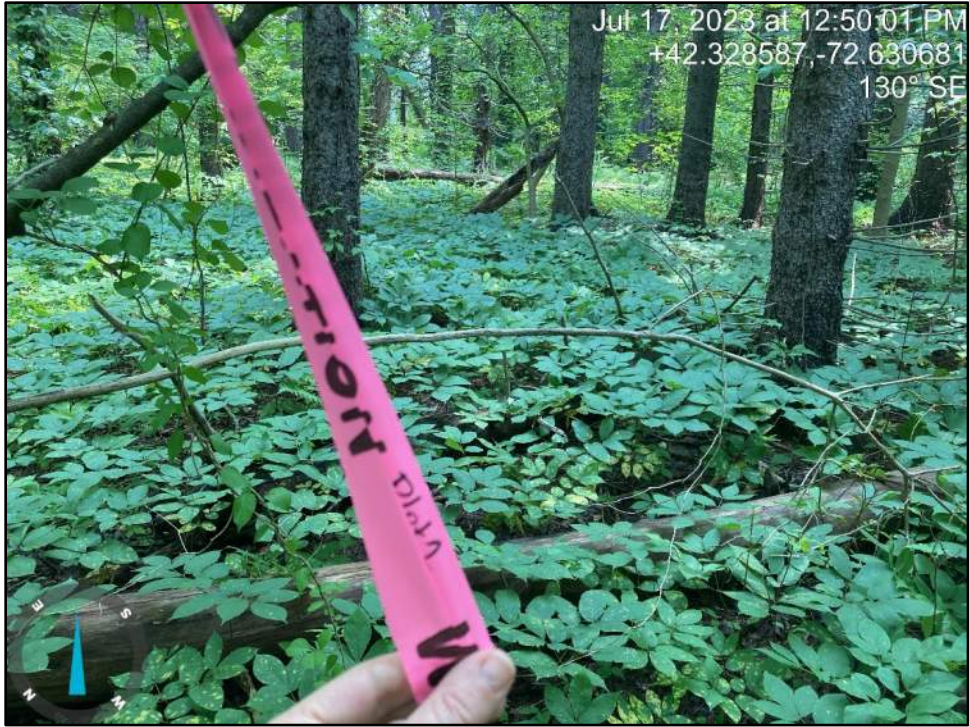
Photo 3. Upland vegetation located at Flag A-69 looking Southeast.

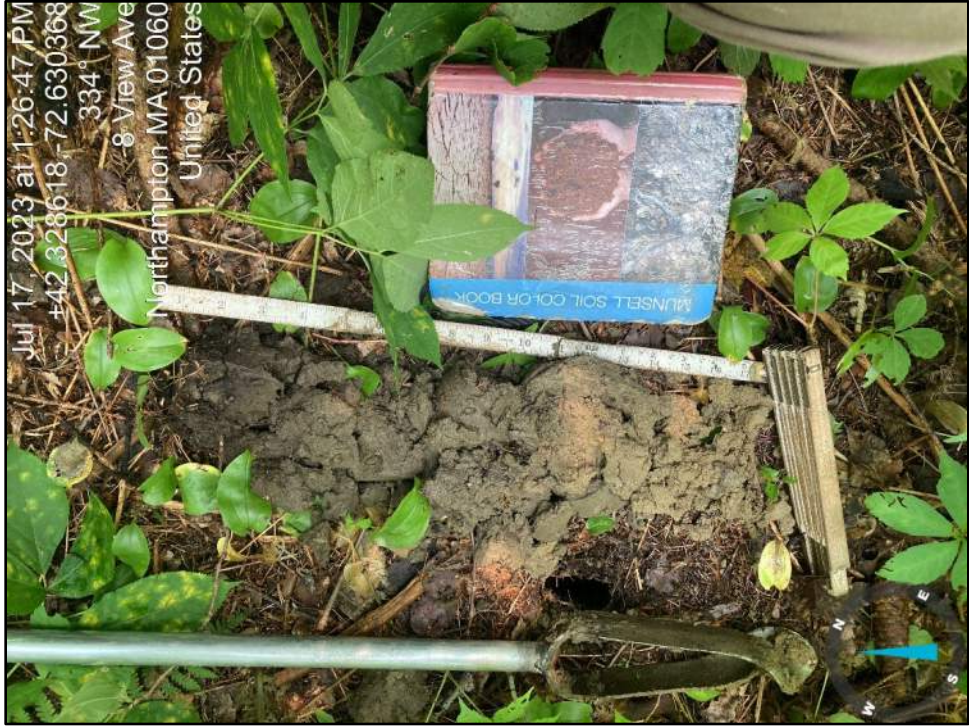
Photo 4. Upland soil profile at Flag A-69.

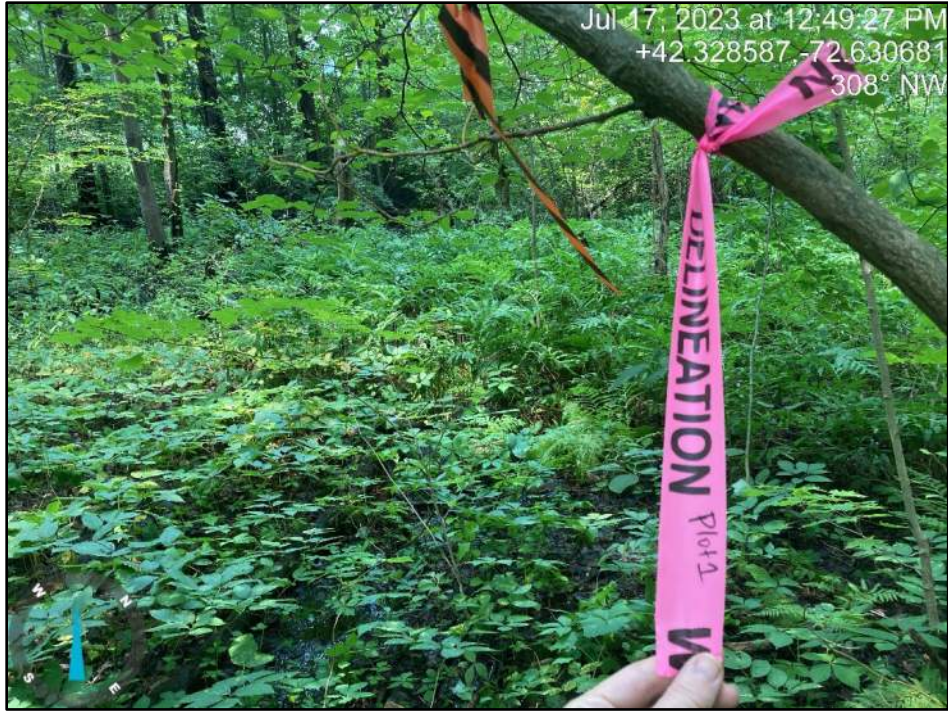
Photo 5. Wetland vegetation located at Flag A-69 looking Northwest.

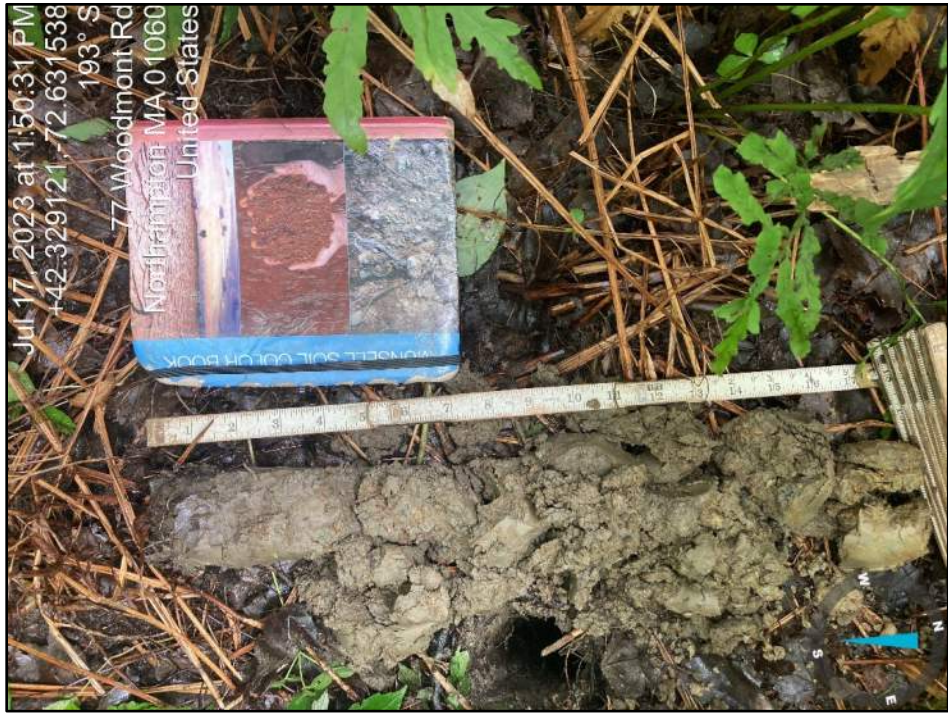
Photo 6. Wetland soil found at Flag A-69.

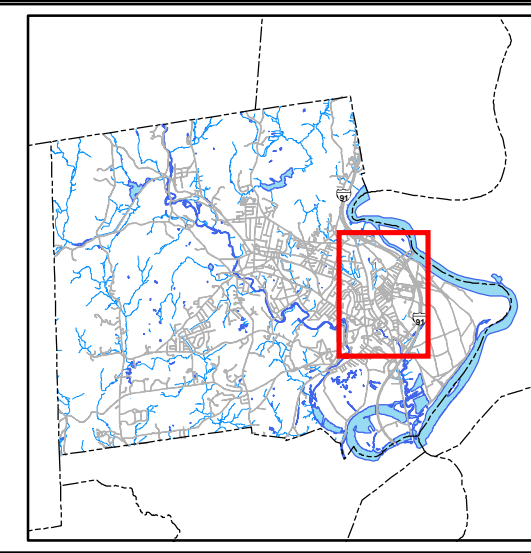
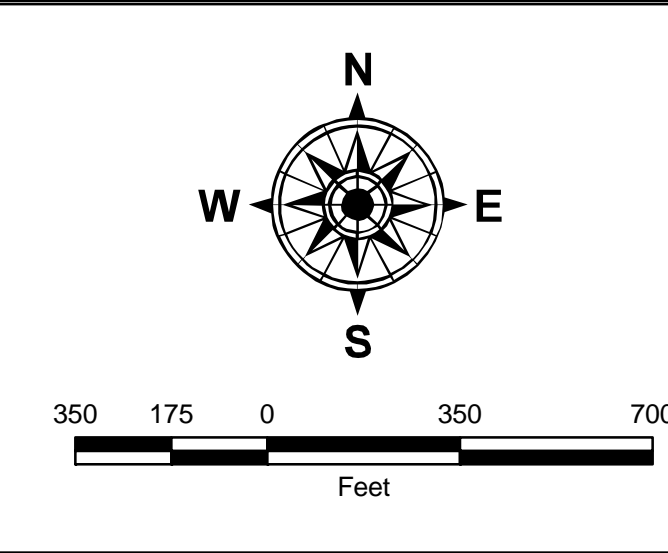
City of Northampton  
 Stormwater and Flood Control System  
 Assessment and Utility Plan  
**Figure 3.1**  
 King Street and Williams Street  
 Brook Drainage Areas

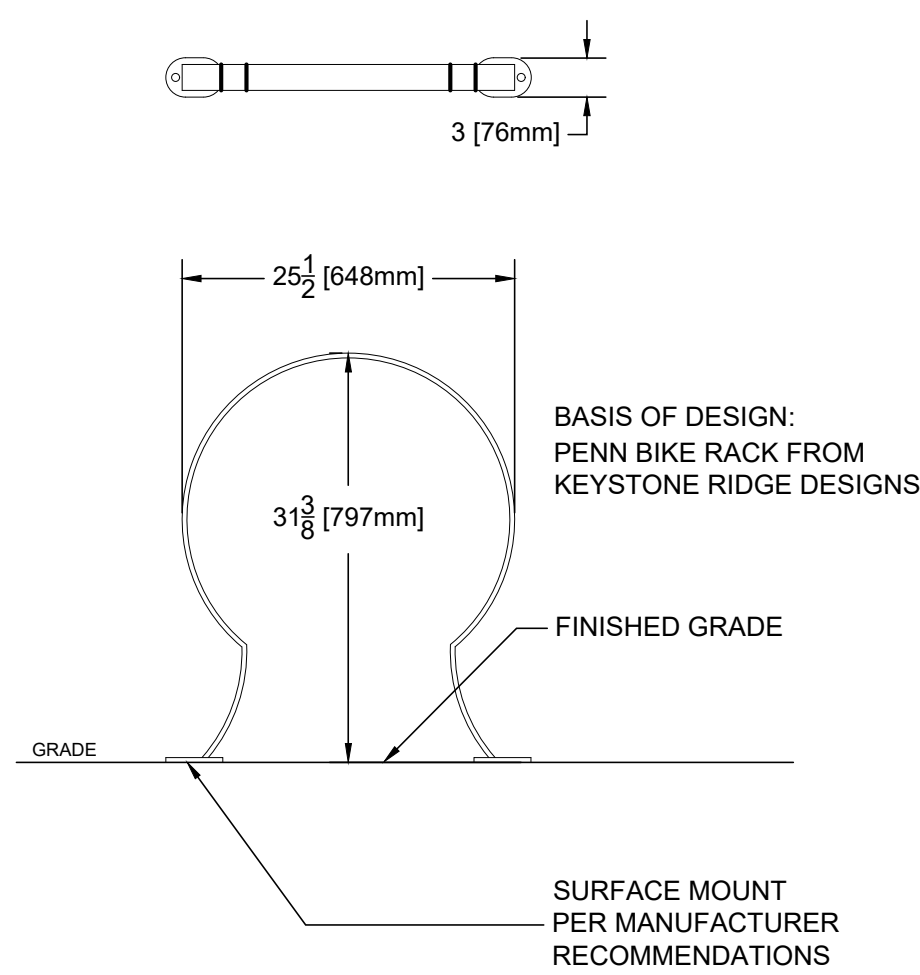
**01 BICYCLE RACK**  
SCALE: NOT TO SCALE

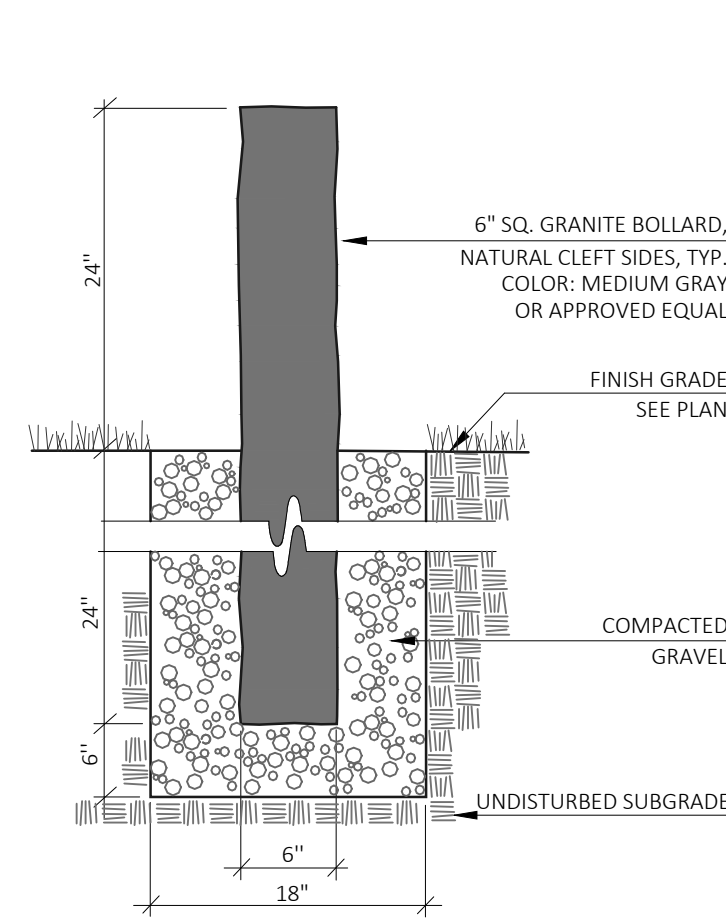
**02 WETLAND MARKER**  
SCALE: NOT TO SCALE

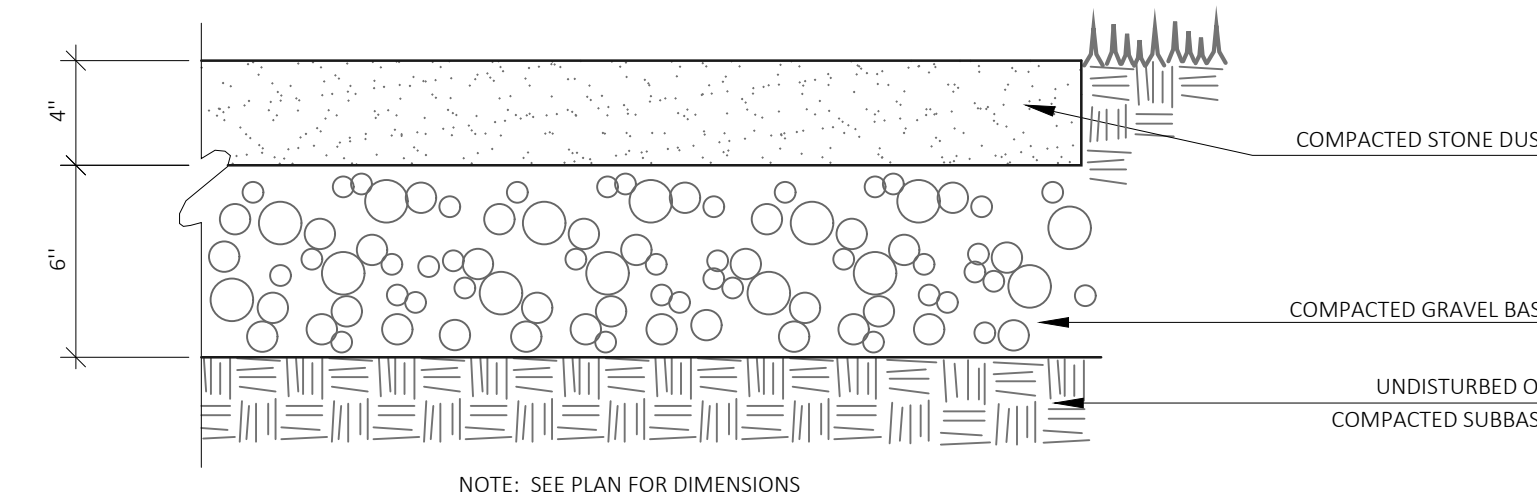
**03 COMPACTED GRAVEL PATH**  
SCALE: NOT TO SCALE

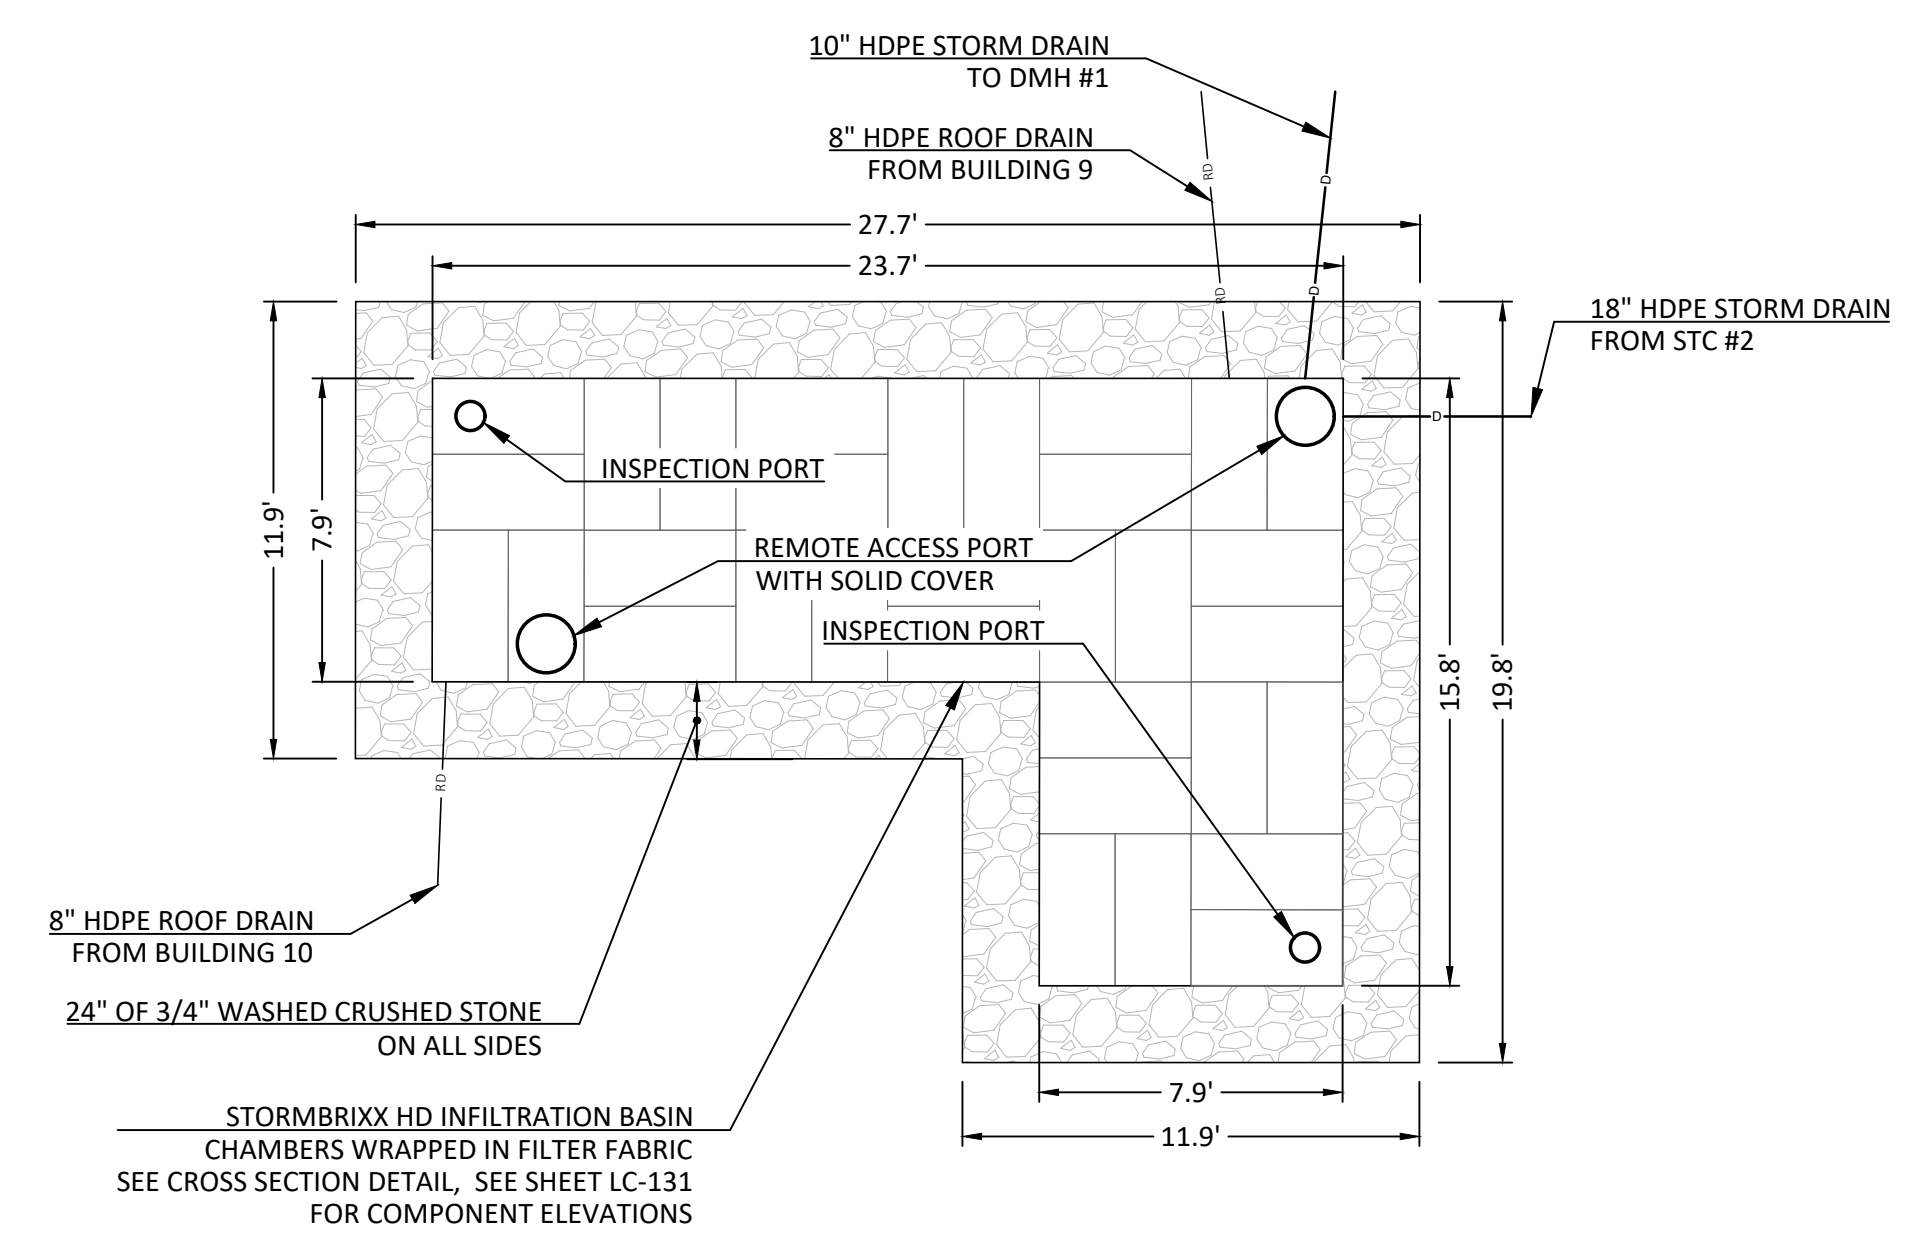
**SUBSURFACE INFILTRATION SYSTEM #2**  
NTS

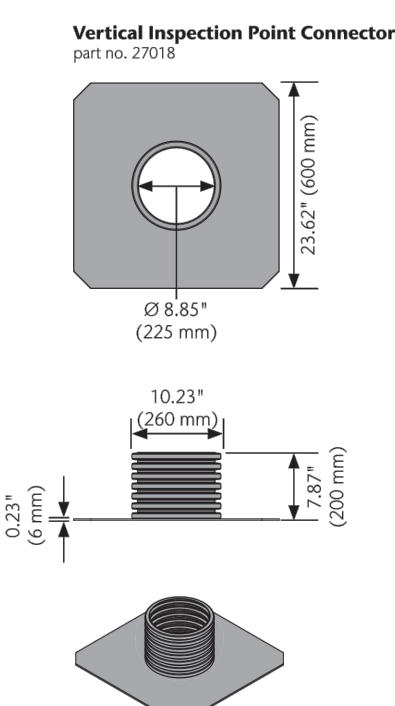
NOTE: INSTALL 9" CAST IRON FRAME AND COVER FLUSH WITH GRADE OVER INSPECTION PORT.

**INSPECTION PORT**  
NTS

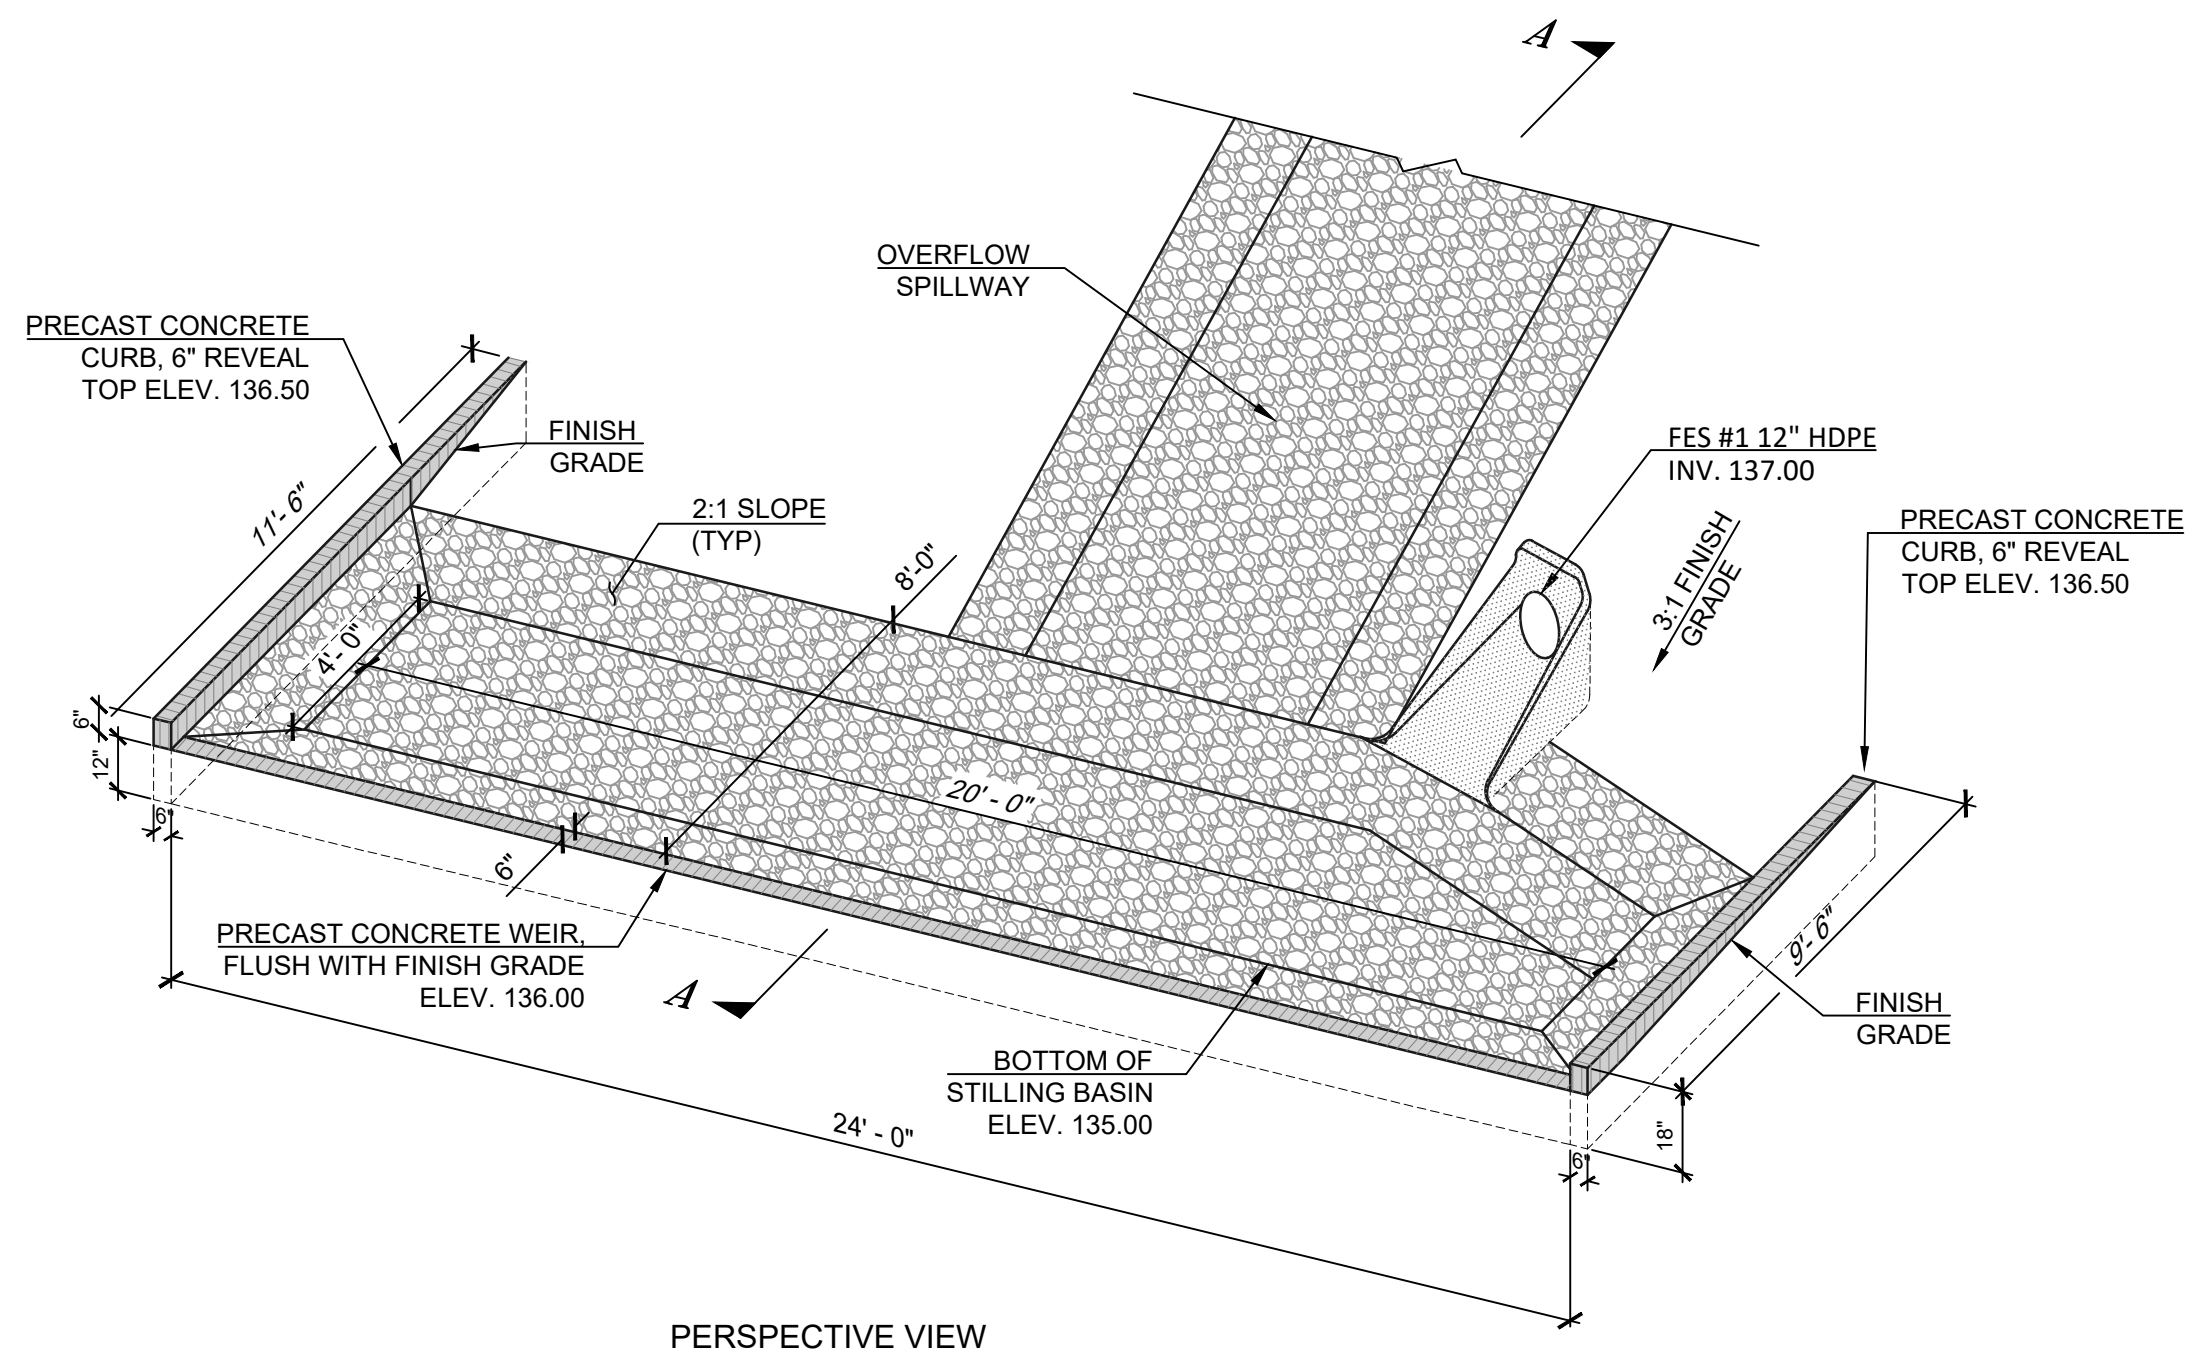
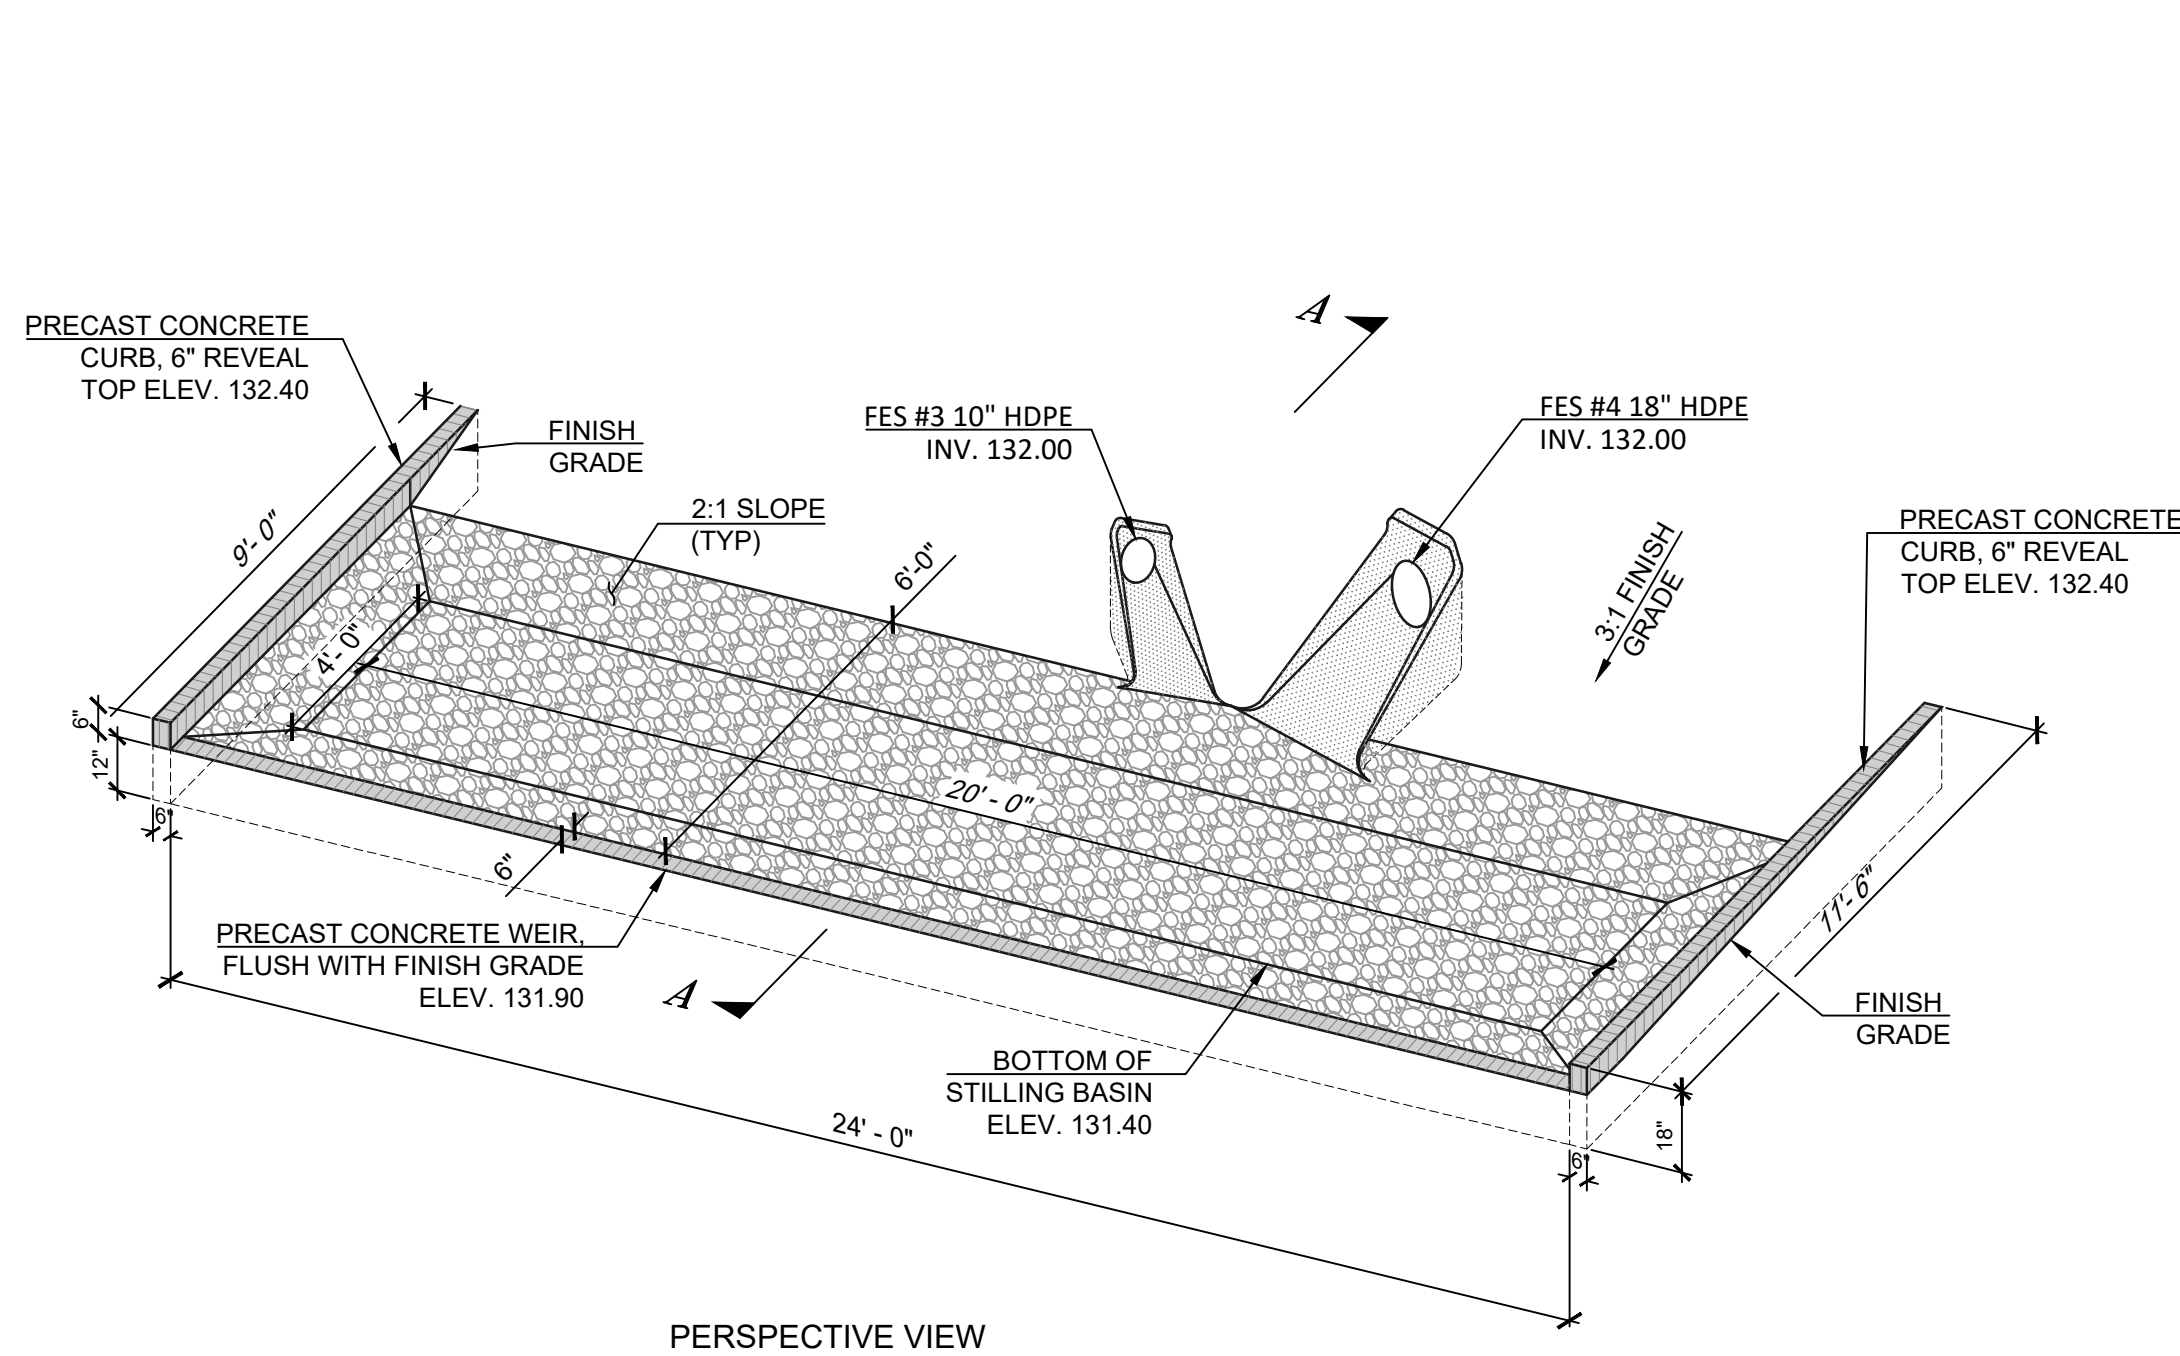
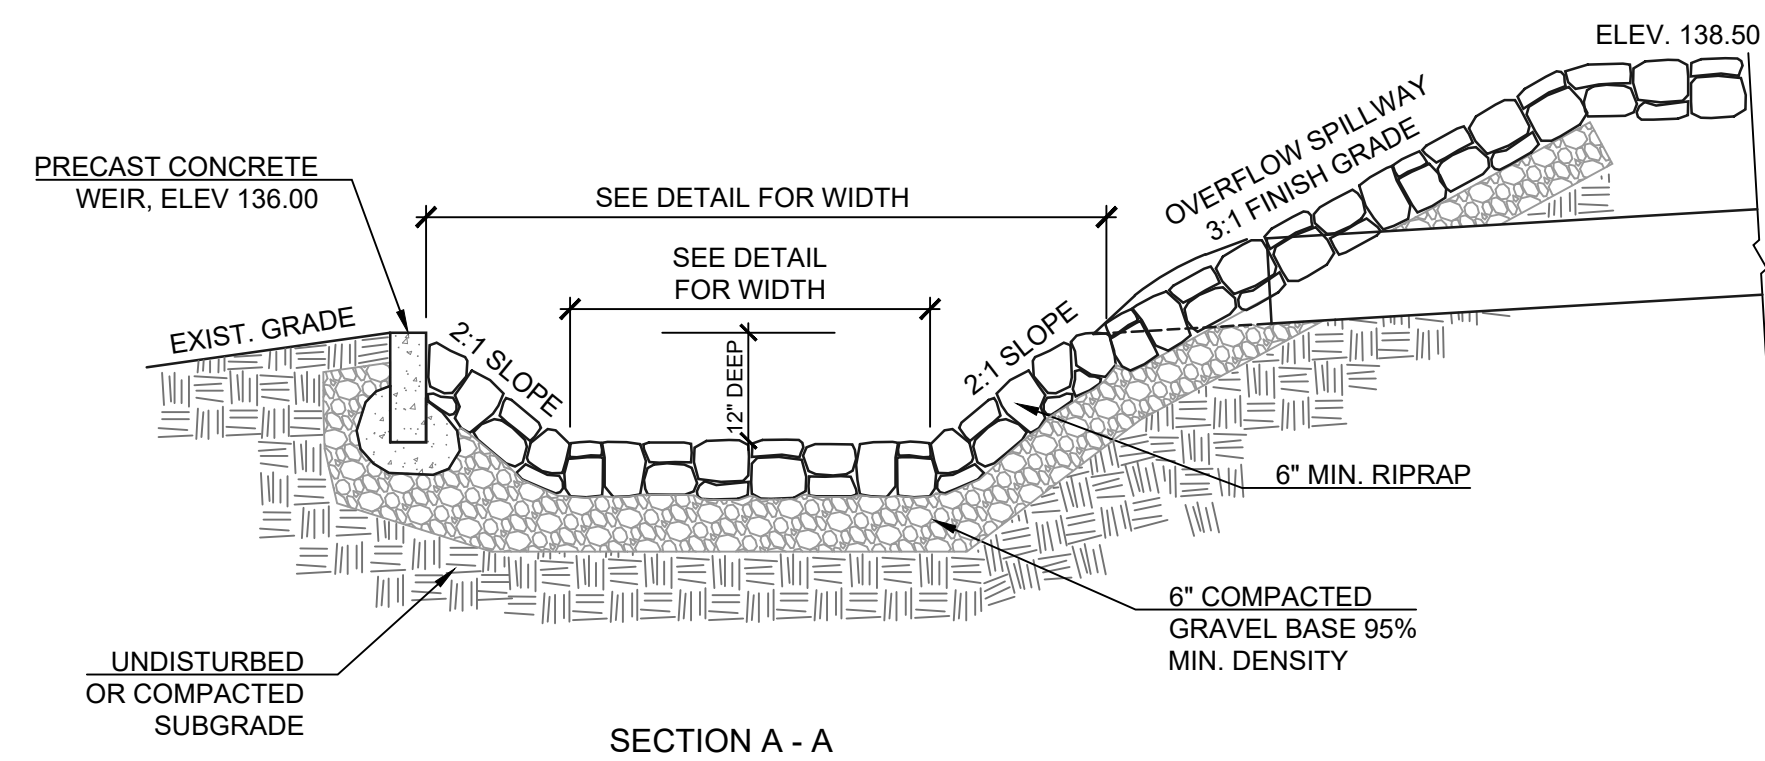
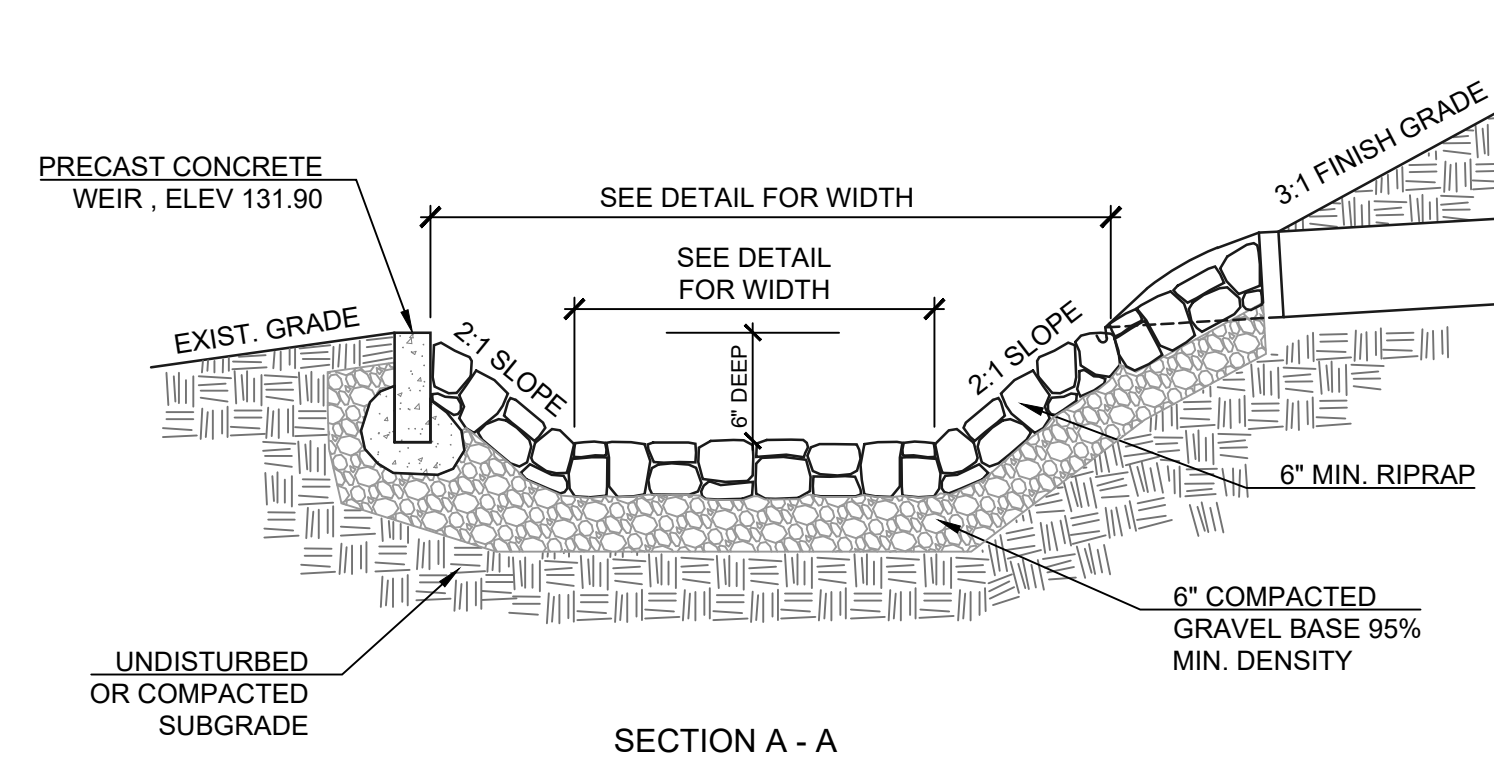
**01 LEVEL LIP SPREADER #1**  
SCALE: NOT TO SCALE

**02 LEVEL LIP SPREADER #2**  
SCALE: NOT TO SCALE
