Estimated Fill Limits

Sovereign Builders  
 8 View Avenue  
 Northampton, MA

**EXISTING CONDITIONS PLAN**

SITE DETAILS

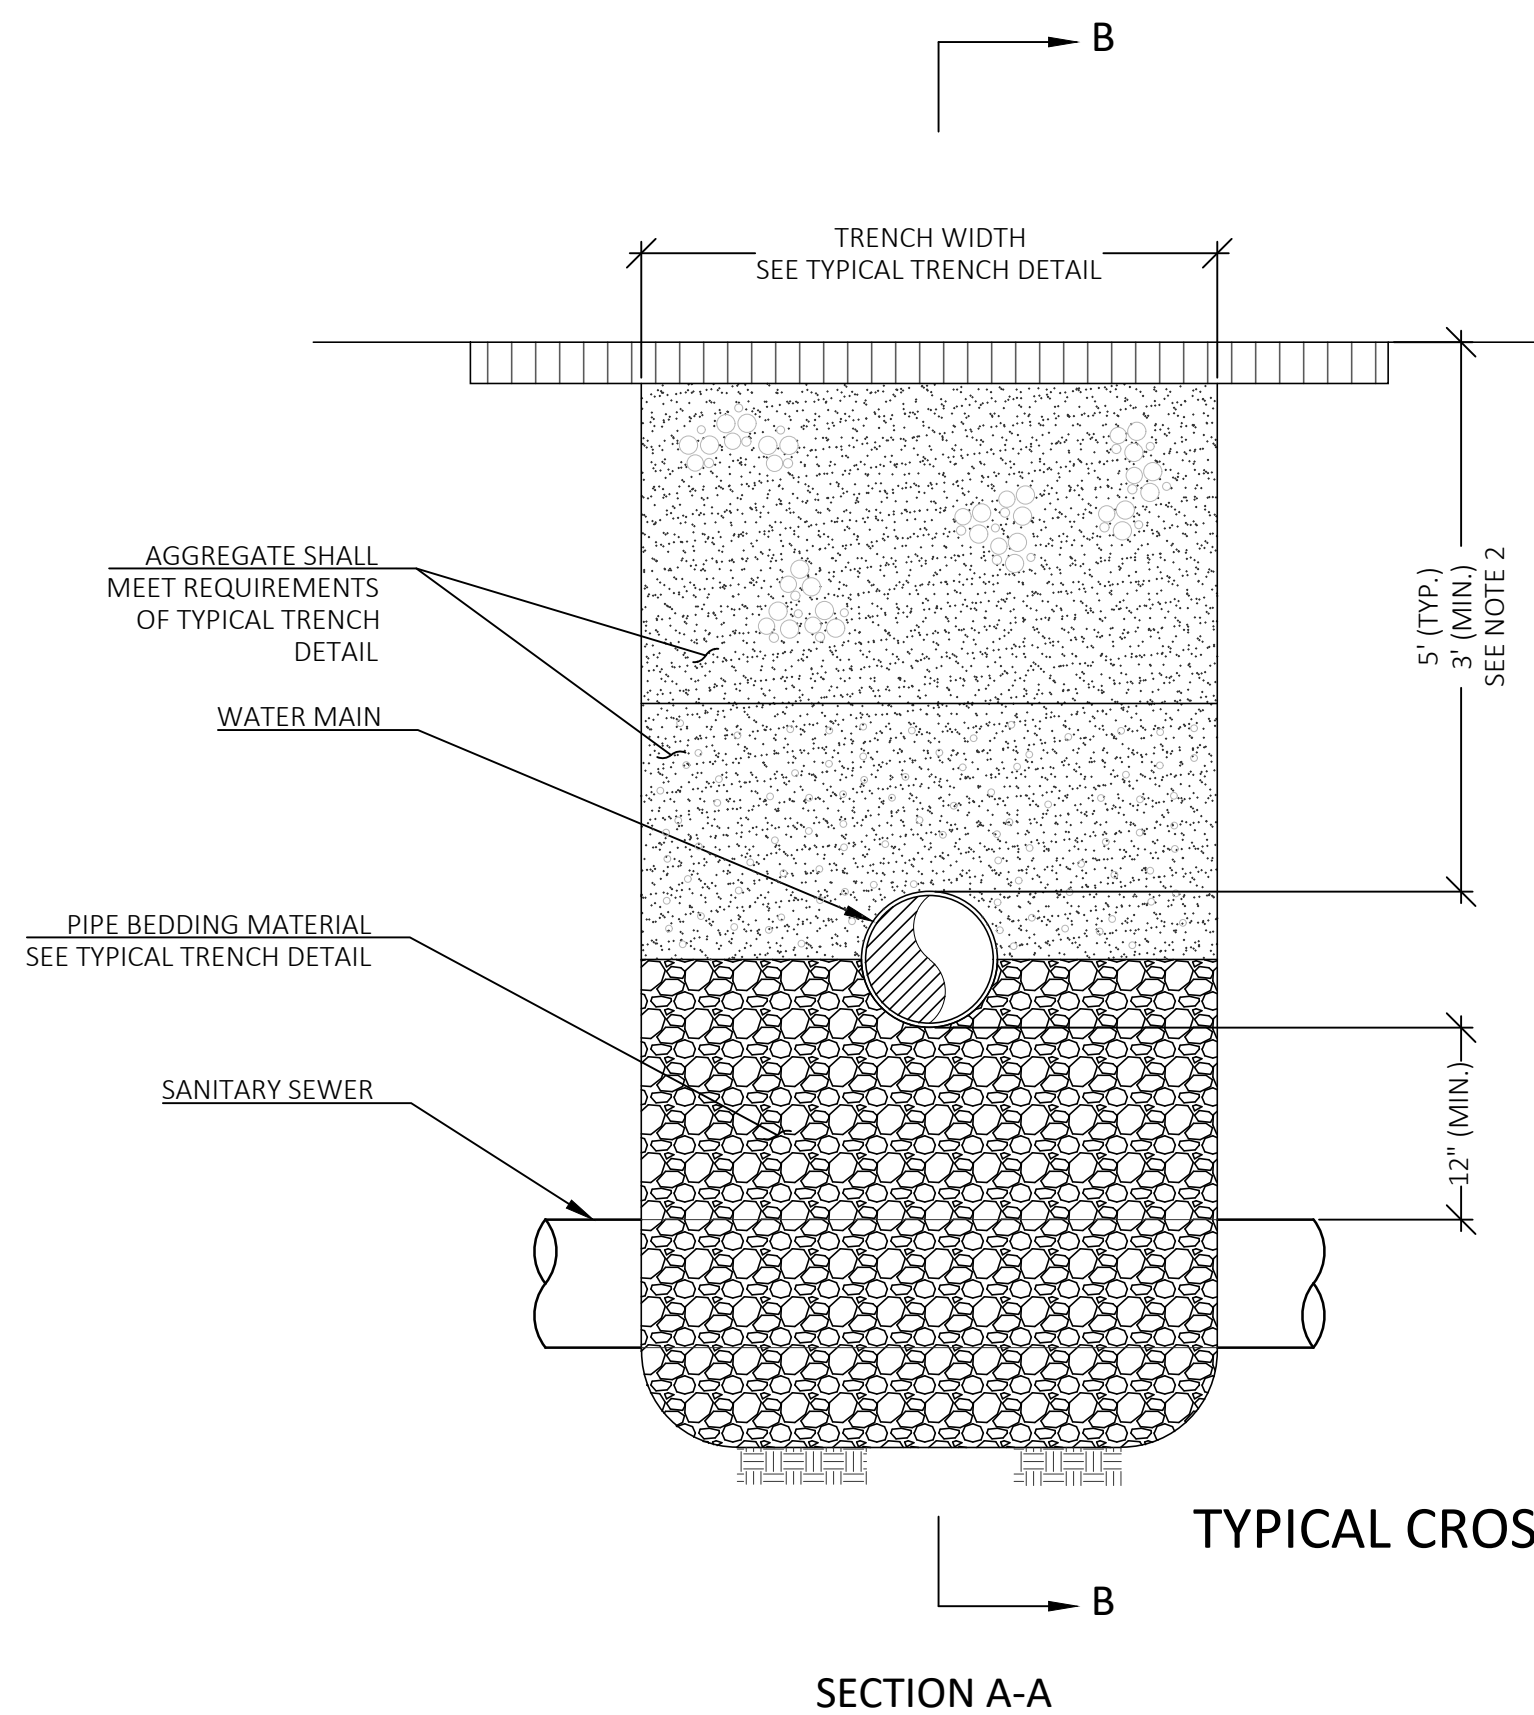
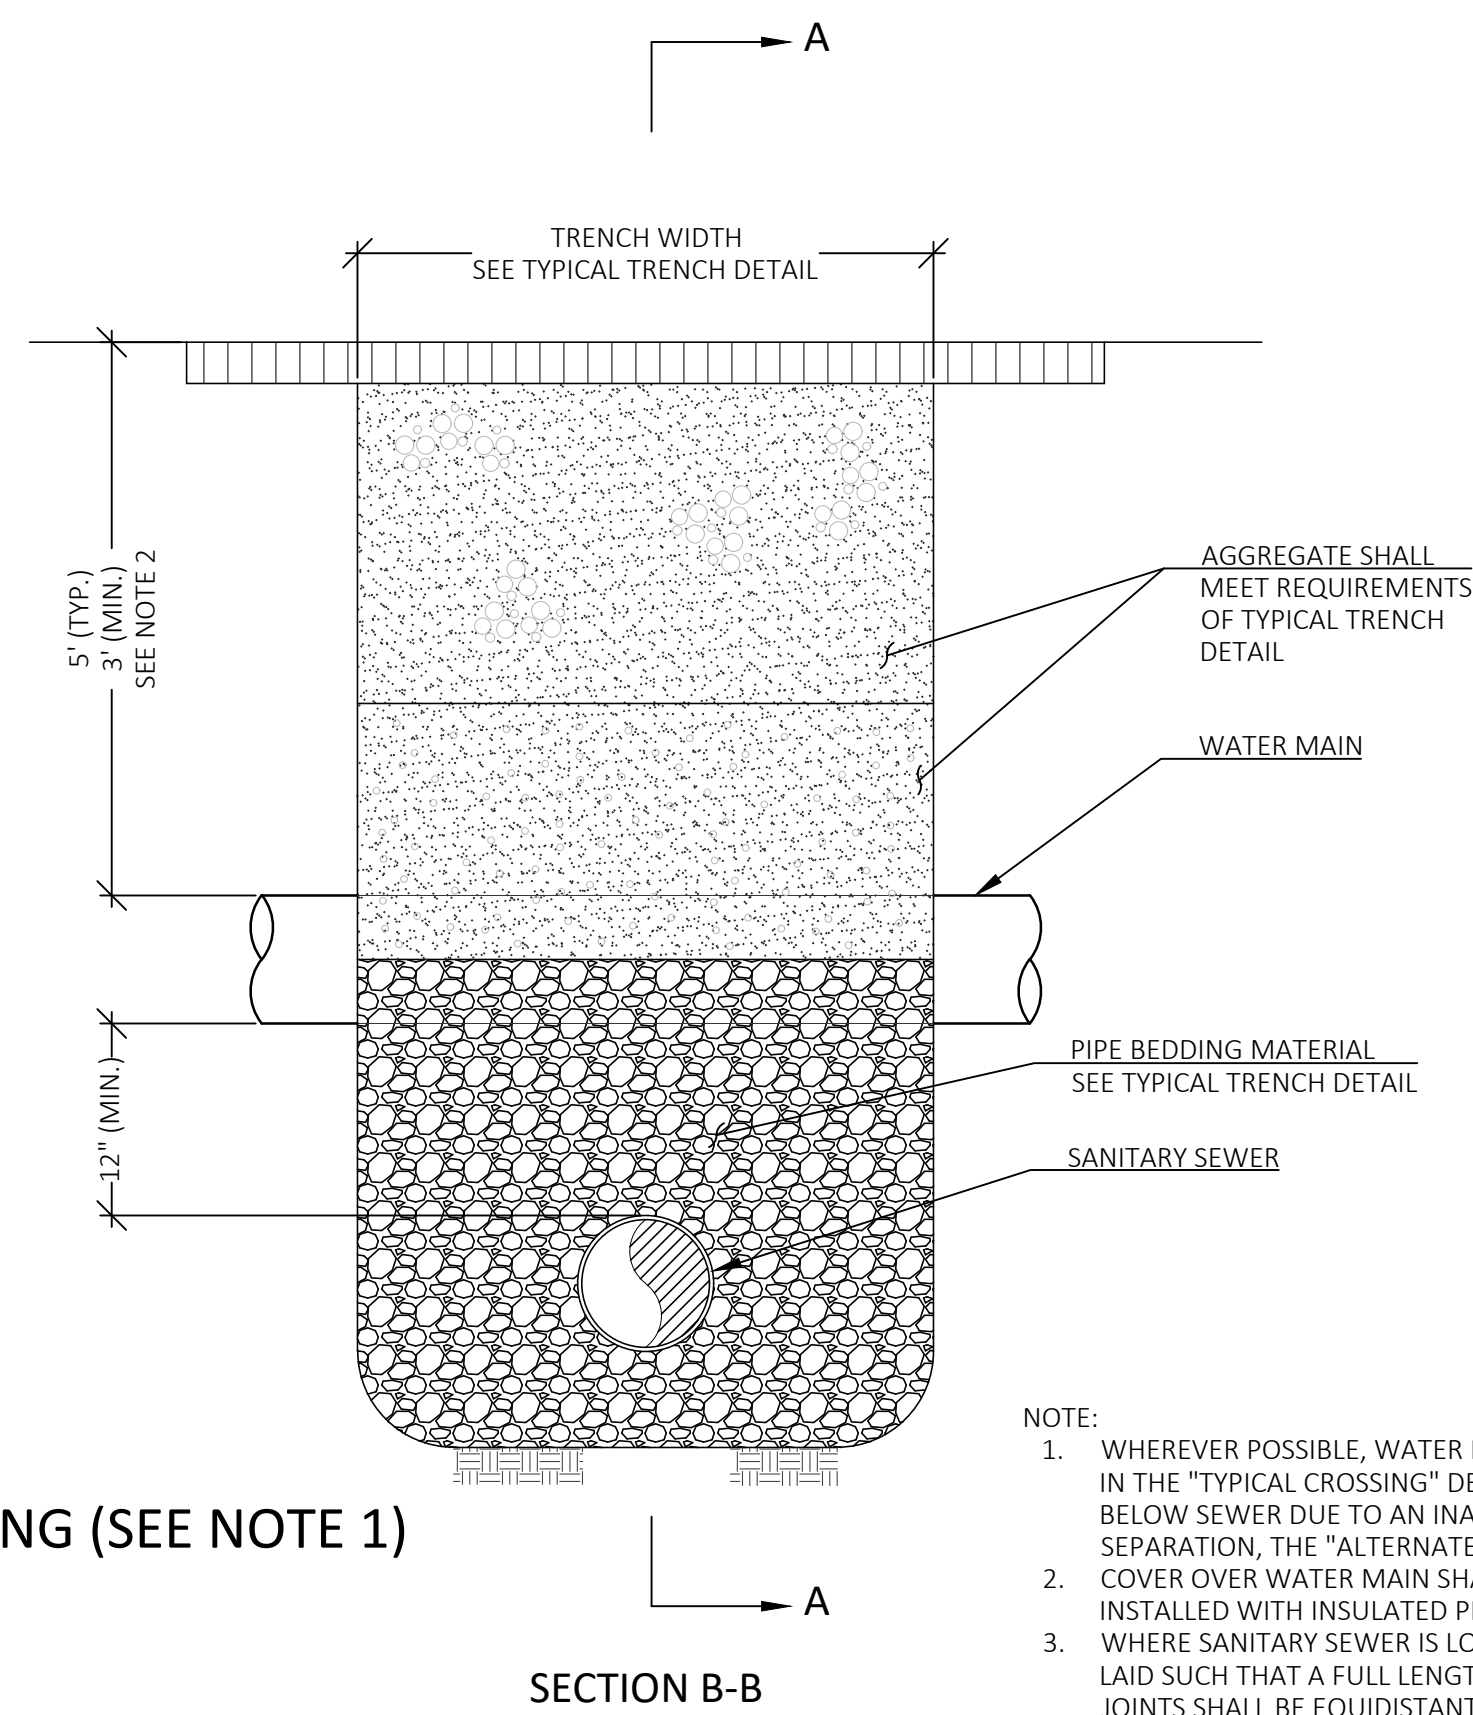
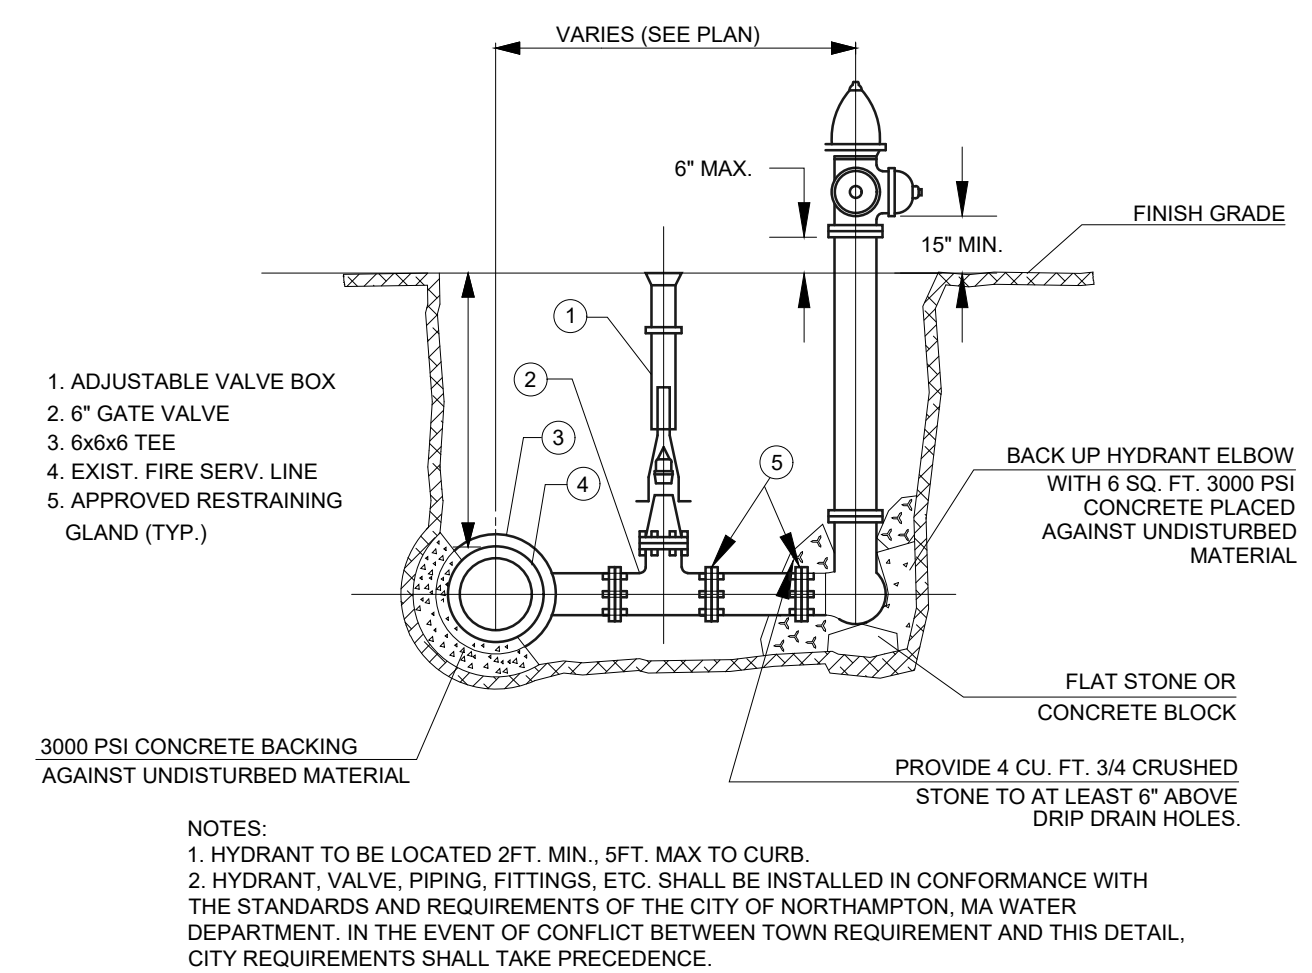
NOTE:  
1. WHEREVER POSSIBLE, WATER MAINS SHALL BE LOCATED ABOVE SEWER, AS SHOWN IN THE "TYPICAL CROSSING" DETAIL. WHERE WATER MAIN MUST BE LOCATED BELOW SEWER DUE TO AN INABILITY TO PROVIDE MINIMUM COVER AND VERTICAL SEPARATION, THE "ALTERNATE CROSSING" DETAIL SHALL BE USED.  
2. COVER OVER WATER MAIN SHALL BE 5' WHEREVER POSSIBLE. WATER MAIN MAY BE INSTALLED WITH INSULATED PIPE AND MINIMUM COVER MAY BE REDUCED TO 3'.  
3. WHERE SANITARY SEWER IS LOCATED ABOVE WATER MAIN, THE SEWER SHALL BE LAID SUCH THAT A FULL LENGTH OF PIPE IS CENTERED ON THE CROSSING, AND JOINTS SHALL BE EQUIDISTANT FROM THE CROSSING.

**04 TYPICAL UTILITY CROSSING**  
SCALE: NOT TO SCALE

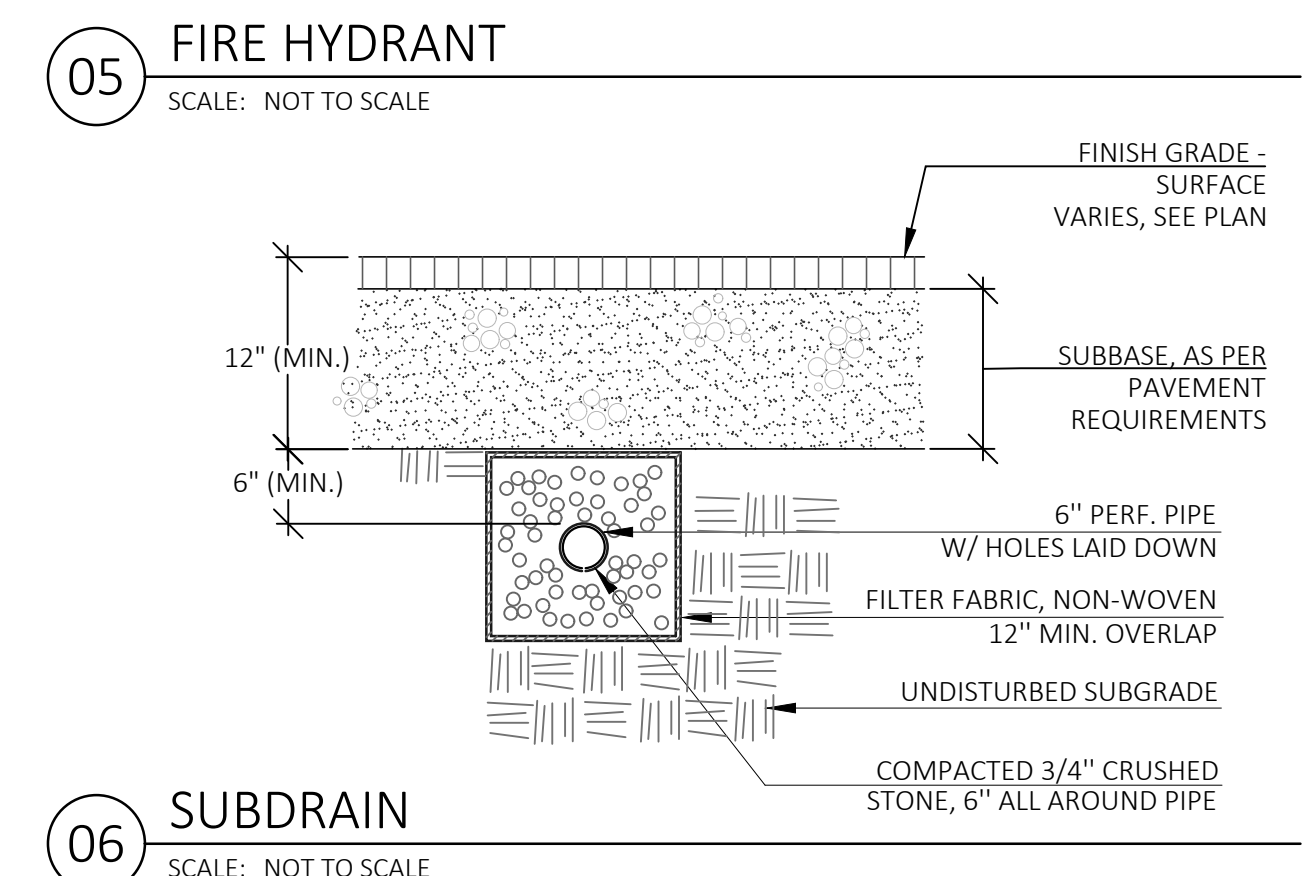
**06 SUBDRAIN**  
SCALE: NOT TO SCALE
