MetroWest Engineering, Inc.

RE: Notice of Intent for 8 View Avenue, Sovereign Builders, Inc.  
MADEP File Number 246-0785

### **Executive Summary**

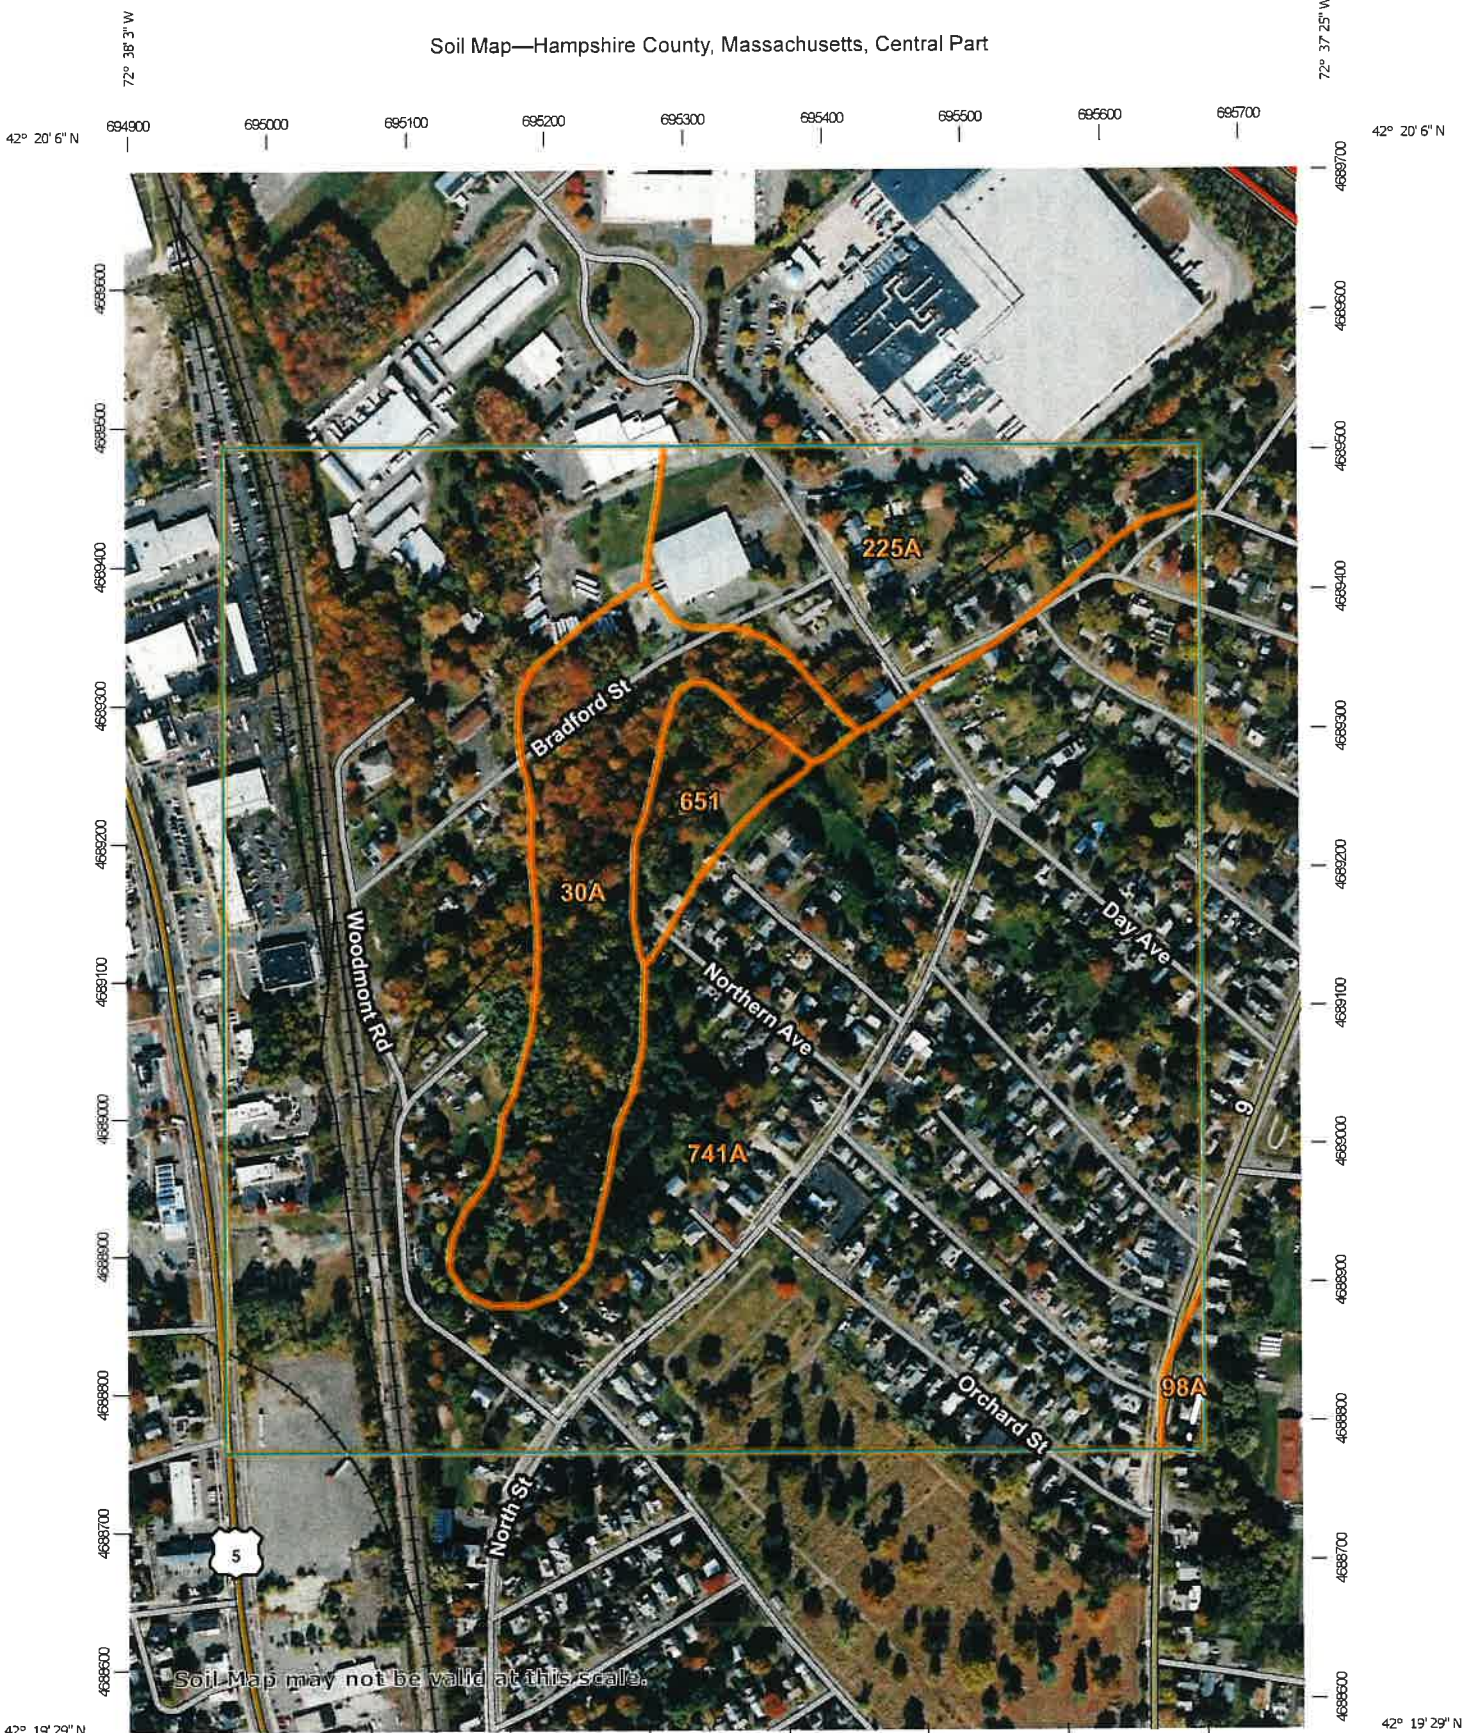
Soil Map—Hampshire County, Massachusetts, Central Part

Soil Map may not be valid at this scale.

Enclosure : USDA NCRS Soil Map and Descriptions
